As You Review Your Roof...

Homeowner's Guide The Life Cycle of Your Roof

What to Expect From Your CertainTeed Roof

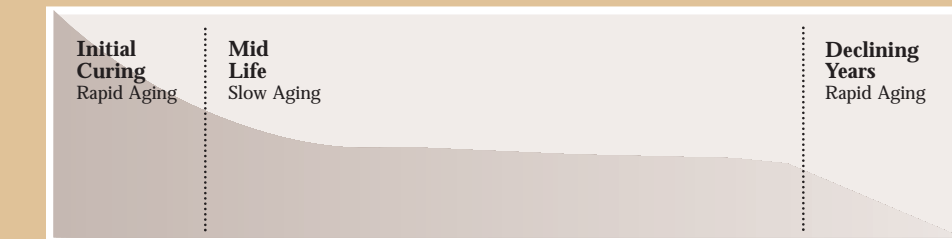
The Life Cycle of a Roofing Shingle

When your new roof was installed, friends and neighbors may have remarked how it enhanced the beauty of your home. However, research indicates that aging begins soon after the shingles are installed and progresses rapidly during the initial curing phase of its life cycle. During this stage, granule loss may occur, small blisters may develop, or the shingles may curl slightly at their edges. You may even notice that this curling is more pronounced during cold weather and the shingles may lie flat as temperatures rise. The good news, however, is that after this curing stage the shingles enter a long period of slow aging, which lasts for the major portion of the shingle's natural life.

During the "mid-life" period, aging continues at a much slower rate. The cracking or granule loss still occurs but does not increase at a noticeable rate. Only after this long period of mid-life does the aging process begin to accelerate once again as the shingles enter their declining years. It's during this period that homeowners normally think about replacing their roofs.
